UNITED STATES ENVIRONMENTAL PROTECTION AGENCY
REGION 6
1445 ROSS AVENUE, SUITE 1200
DALLAS, TX 75202-2733

March 12, 2013

My name is Ursula Lennox, and I am a Remedial Project Manager, in the Superfund Program at the U.S. Environmental Protection Agency Region 6 (EPA), and responsible for the implementation of the February 2008 Operable Unit 4 - Record of Decision (ROD) for the Tar Creek Superfund site. Your inquiries to EPA's Contractor – CH2M HILL, involving the restoration work that was completed on your family's property (Distal 2) were forwarded to me. I would like address your concerns mentioned in your inquiries involving "rocks scattered about the acreage", seeding that was performed, and the desire to "pursue possible avenues that might help rectify this predicament".

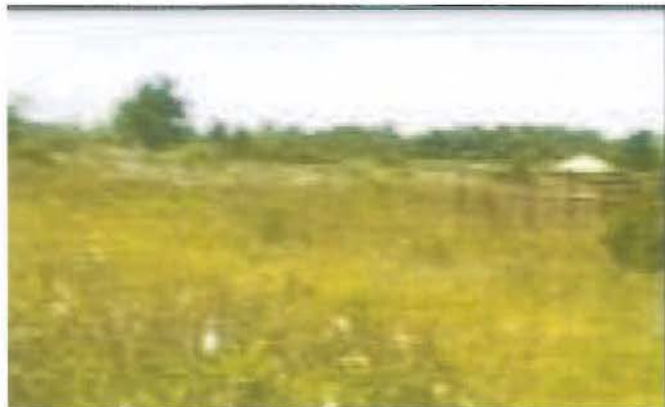
Looking SW across CB046

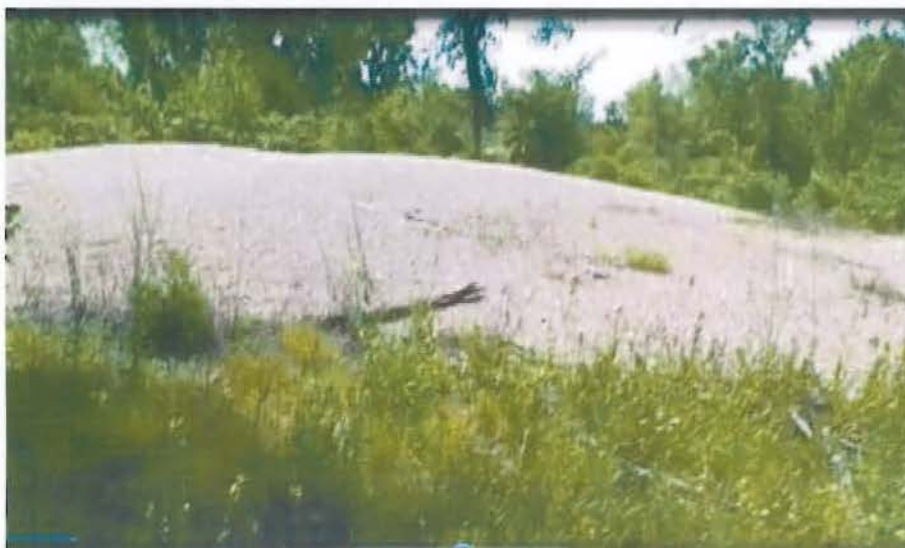
Northern edge of CB046

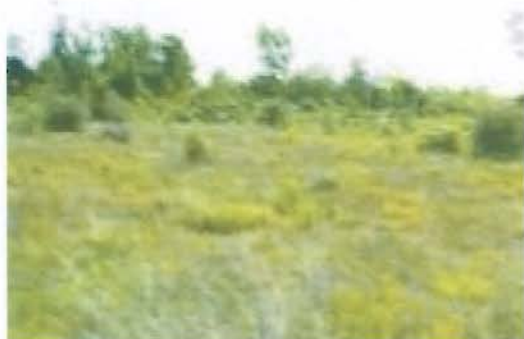
Southern area CB048

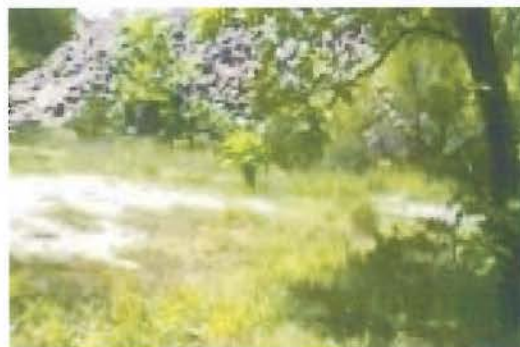
Southern Boundary, CB046

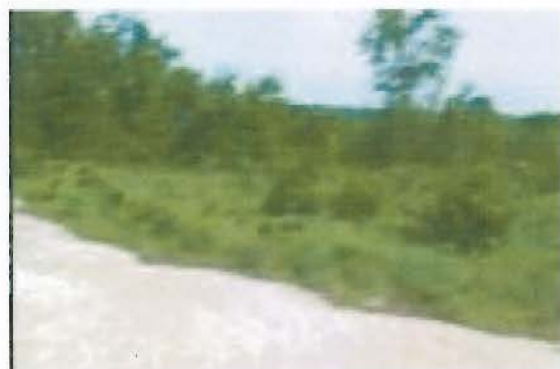
Southern edge of CB048

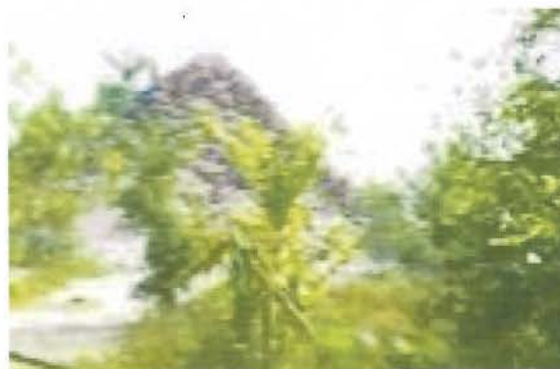
South – SE side of CB053

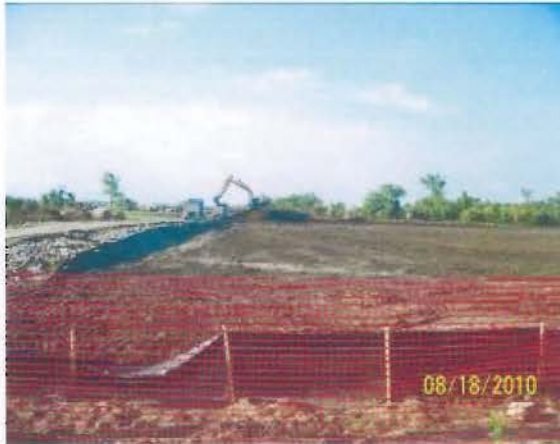
PHOTO 1
Distal Group 2
Excavating source material at CB044

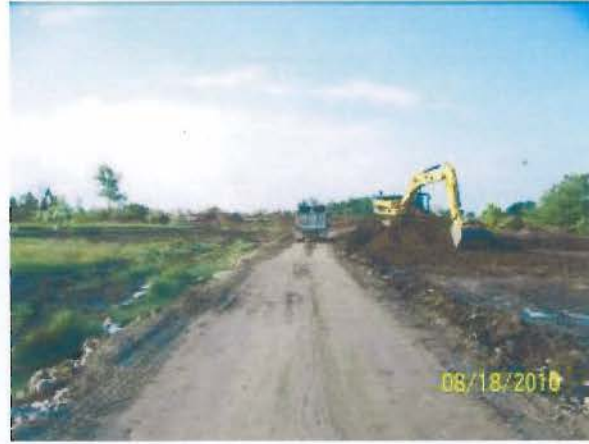
PHOTO 2
Distal Group 2
Loading haul truck using source material from CB044

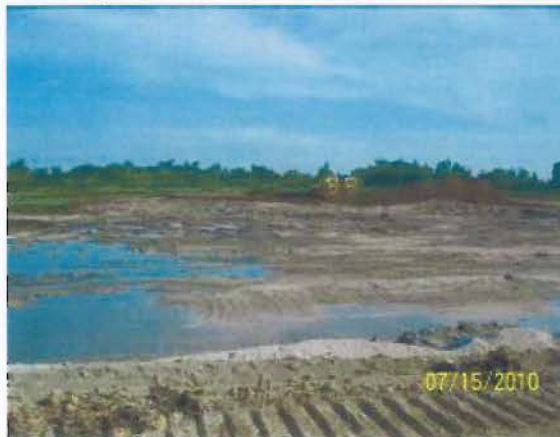
PHOTO 3
Distal Group 2
Excavating source material at CB046

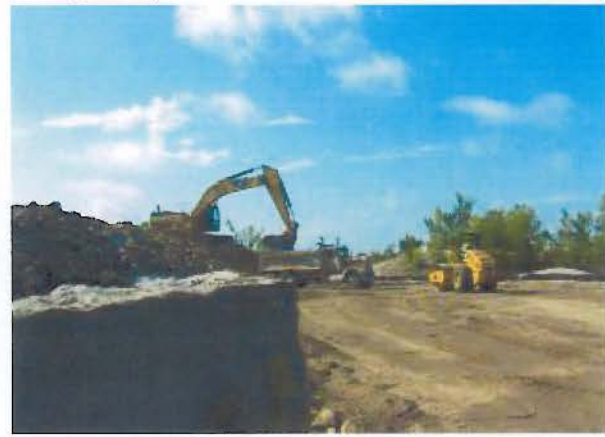
PHOTO 4
Distal Group 2
Loading development rock in haul truck from CB046

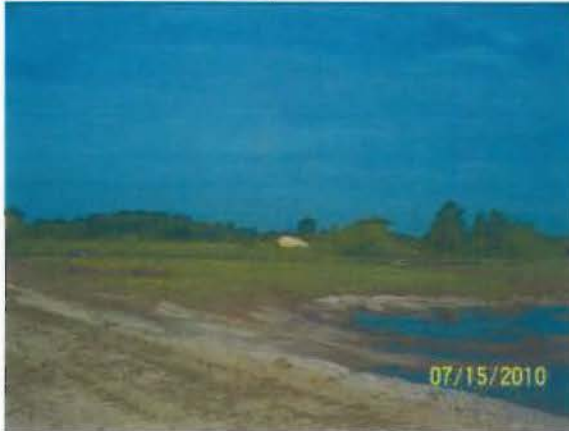
PHOTO 5
Distal Group 2
View of CB046 with satellite pile S-4

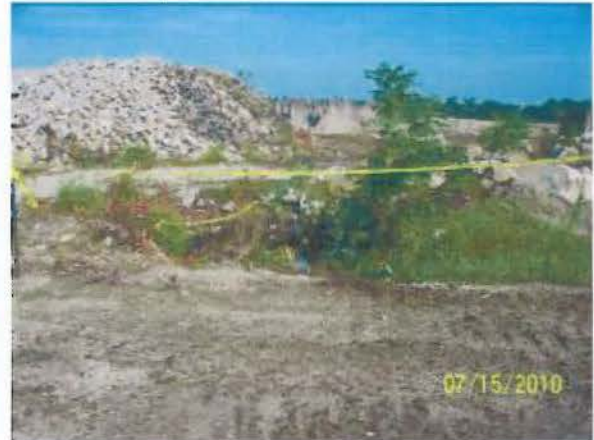
PHOTO 6
Distal Group 2
View of satellite pile S-1 subsidence

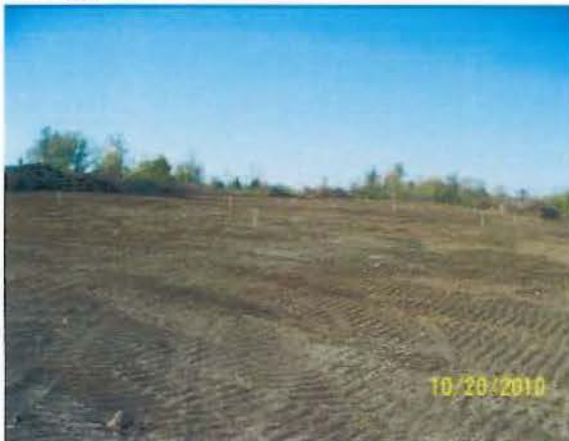
PHOTO 7
Distal Group 2
View of CB048

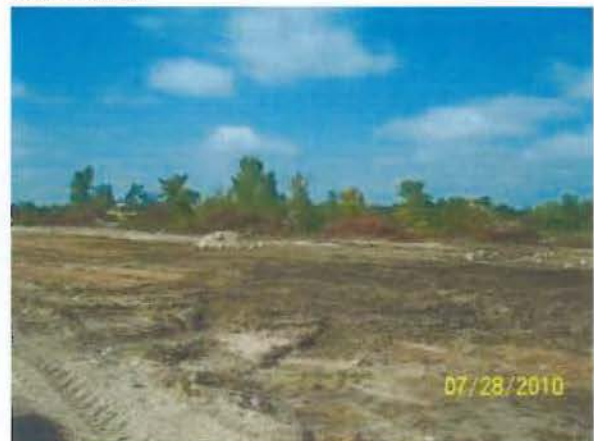
PHOTO 8
Distal Group 2
View of CB049

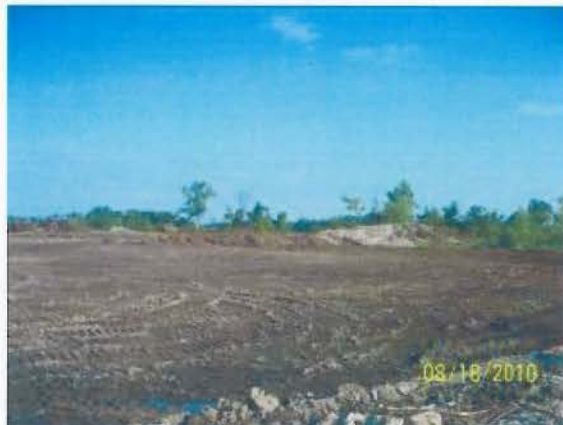
PHOTO 9
Distal Group 2
Excavating source material at CB053

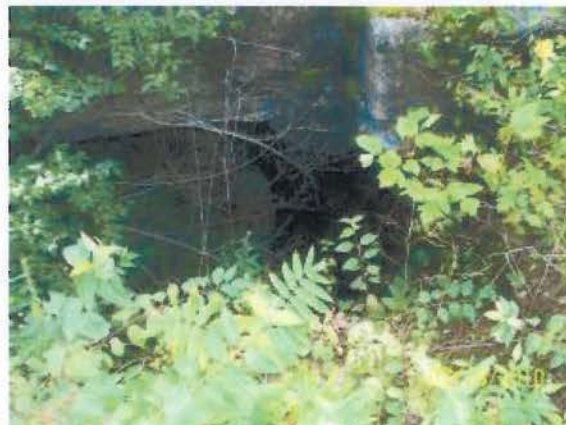
PHOTO 10
Distal Group 2
Deep shaft covered with concrete observed at CB053

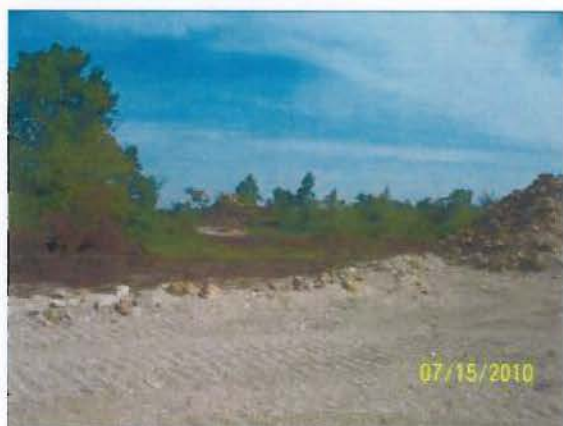
PHOTO 11
Distal Group 2
Satellite pile observed at CB053

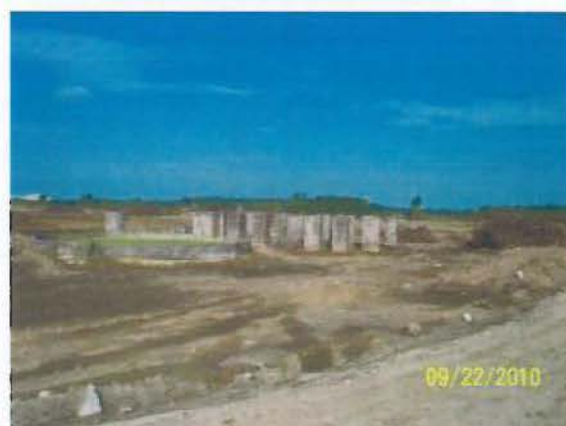
PHOTO 12
Distal Group 2
Close up of structures observed at CB053

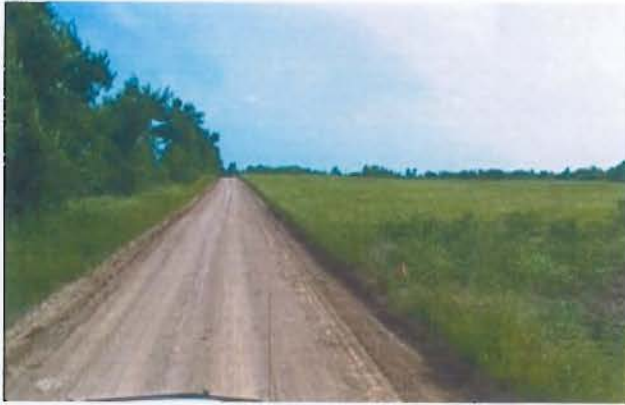
CB049 Looking East from West side of site

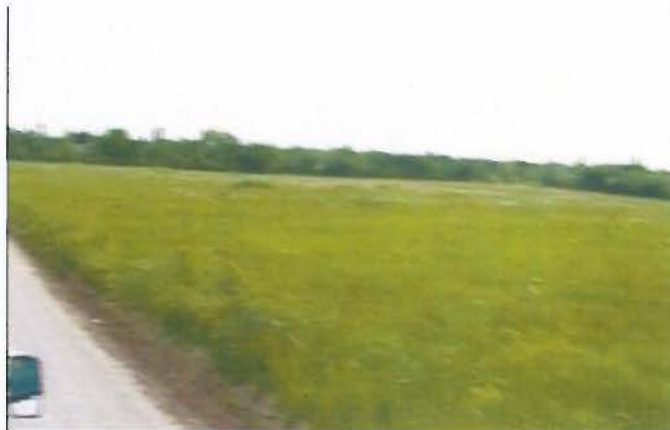
CB049 Looking SW from 600 Road toward Railroad Grade

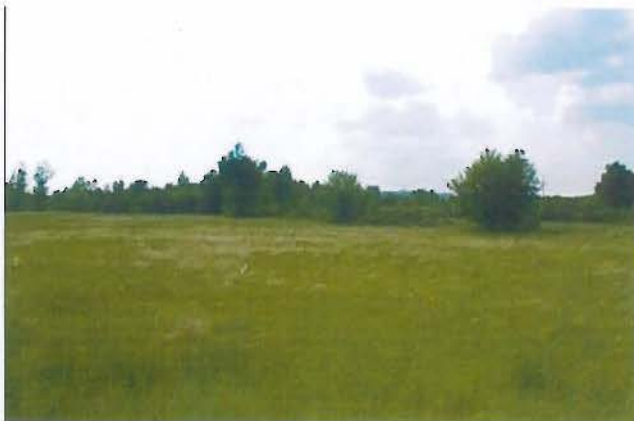
CB-049 Northern boundary
